Two Electrical Forensic Engineering Case Studies

Kurt Clemente, *Senior Member, IEEE*, and Erling Hesla, *Life Senior Member, IEEE*

III. CASE STUDY #1: DATA CENTER POWER FAILURE

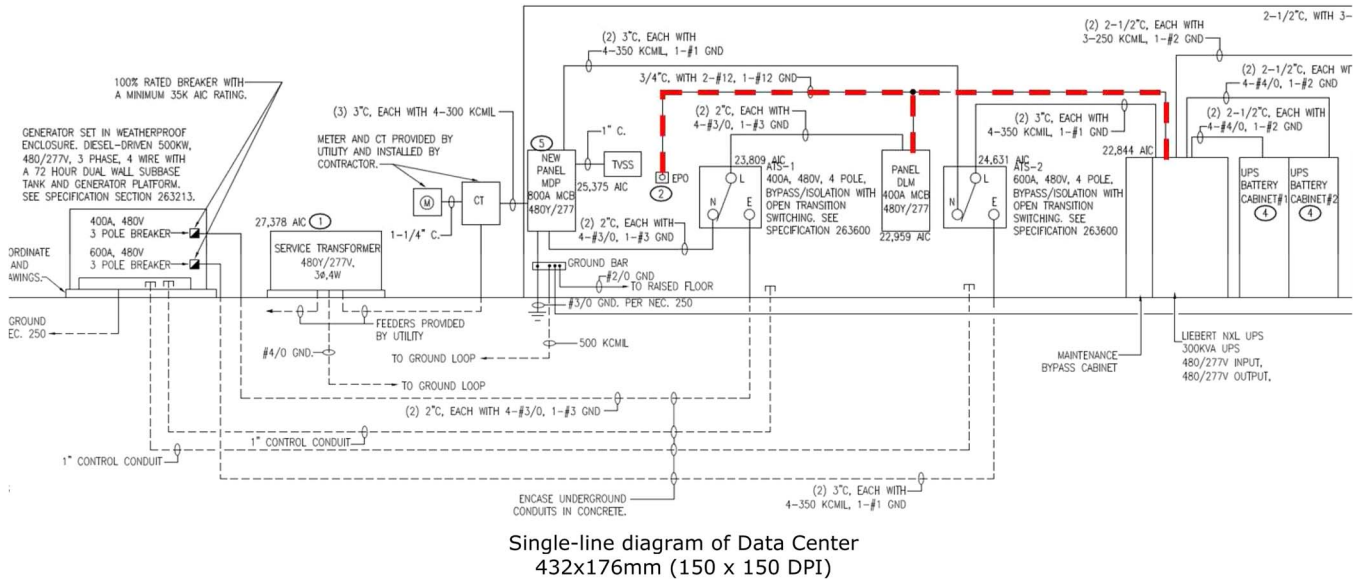
Fig. 1. Single-line diagram of the data center.

distribution system is shown in Fig. 1. The connection highlighted by a dashed line is intended to provide a Building Code-required emergency power-off (EPO) capability for equipment shutdown.

Having determined the proximate cause of the data center failure was the deactivation of the UPS by receipt of an EPO shutdown signal, the engineer focused his attention on the design of the EPO control circuit. The circuit collected shutdown signals from multiple input sources, including two manual pushbuttons at the building entrances, a fire alarm control panel, and a clean agent control panel. Shutdown by manual pushbutton is a code requirement [4], whereas shutdown upon activation of a fire alarm or clean agent discharge is a recommended practice for data centers [5]. Upon receiving any shutdown input signal, the circuit operated a 120-VAC power circuit to accomplish necessary equipment shutdown. The EPO circuit distributed this shutdown signal to the stored energy of the UPS and to the dedicated HVAC units in the data center. While the HVAC circuit breakers were factory-equipped with a shunt trip coil operated directly from the 120-VAC shutdown signal, the UPS required a "dry contact" activation signal for shutdown. While code requirements do not prevent using two separate EPO control circuits to deliver these two very different activation signals, the contractor for the data center elected to use a single circuit to deliver both signals by means of a relay. Design documents were unclear on how the contractor was to activate the dry contact from a 120-VAC activation signal, and the contractor selected a Form "B" normally open relay in a "fail-safe" configuration; the contacts were held open during normal operation (absence of a shutdown signal), but if the EPO circuit itself were to de-energize, the relay contacts would close. Design documents provided UPS-protected power for the EPO circuit to ensure circuit behavior would be independent of power outages, but field inspection during the investigation revealed that the contractor had installed the EPO circuit with non-UPS-protected power. "Fail-safe" operation therefore should not have been an issue as designed, but a seemingly innocuous field wiring change exposed this issue.
